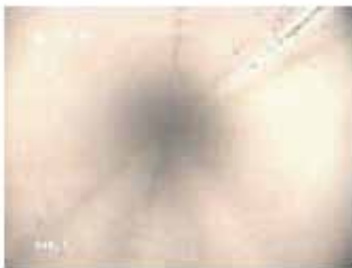
Figure 1 :: Small dark stains on seams.

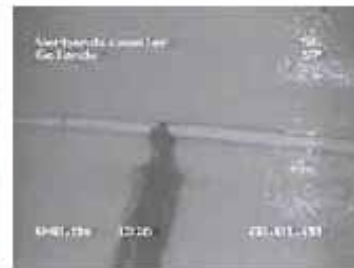
Figure 3 :: Severe stains.
