## Liners Troubleshooting Manual :: Unevenness On Liners

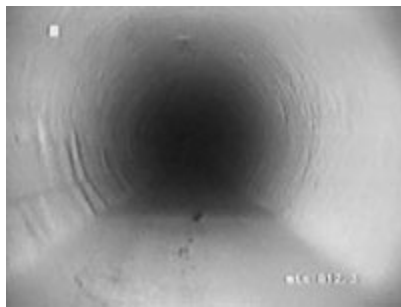
An uneven finish has been observed on finished liners. Unevenness is characterized by an undulating surface with circumferential "ridges" and/or "furrows".

**Figure 1 :: Slightly uneven finish at 7 o'clock pulling across a seam.**

**Solutions:** An uneven finish on the surface of a liner may be a function of the coating thickness and the properties of the underlying felt. This is an issue which may require a fundamental examination of these material properties. Air pockets behind liners are avoided by ensuring that the liner or calibration hose is kept tight during inversion.

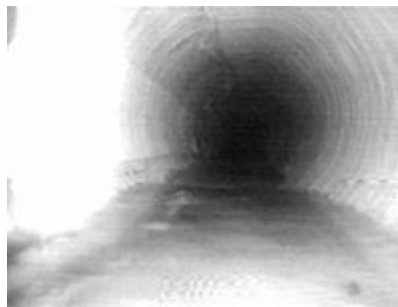
**Figure 2 :: Almost complete circumferential undulations.**

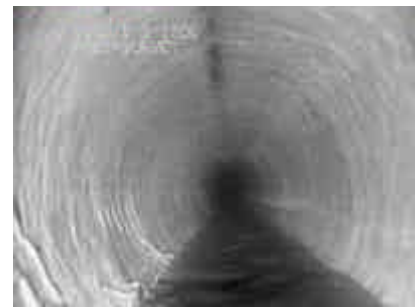
**Figure 3 :: Almost complete circumferential undulations.**

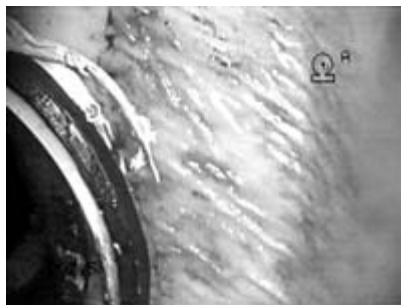
**Causes:** The formation of an uneven surface on the internal surface of liners is characterized by a rippled surface which can be seen in the close-up in Figure 4 below.

The coating surface can become uneven after impregnation if the lining is retained without sufficient refrigeration. Under these conditions the styrene monomer can cause the coating to swell relative to the underlying felt resulting in an uneven surface. Air pockets can occur behind the seam (see Figure 6) due to a number of factors.

**Figure 4 :: Close-up view of uneven surface.**

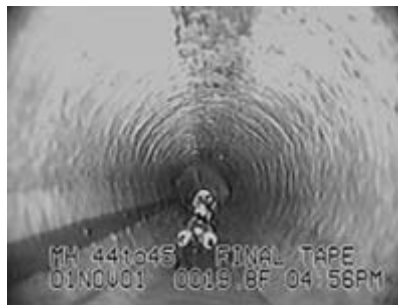
**Figure 5 :: Increasingly severe undulating surface.**

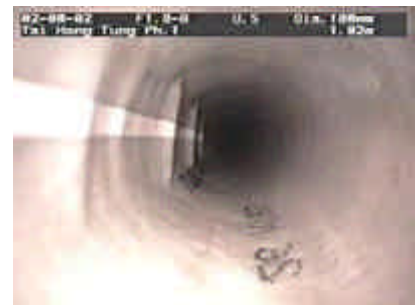
**Figure 6 :: Example of air pockets behind the seam.**
