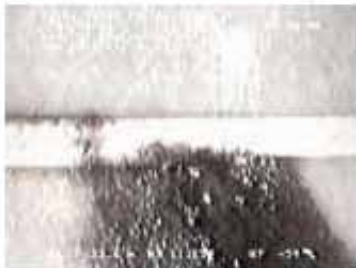
Causes: Reasons for the formation of leaks on seams are associated with the initial formation of a hole in the seam brought about at some stage during installation.

Prior to this, any holes would have been apparent during impregnation. Once water/air/steam during cure has a route out through the liner, groundwater can then follow the same route producing the features in the Figures below.

A stress raiser at the edge of the seam tape may induce a split under excessive load.

Figure 1 :: Small leak.

Solutions: Leaks on seams can be avoided, where they are brought about by damage to the seam through careful handling. Damage can occur by allowing the liner to run over rough surfaces.

During impregnation and installation ensure that all rollers and elbows (where a bottom inversion is used) are clean and smooth.

After impregnation and storage for transport, the seam area can swell making the seam more vulnerable to damage.
