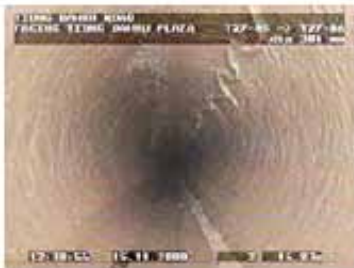
Figure 1 :: Small longitudinal fin.

Fins have been observed on finished linings. They are raised localized ridges which appear to involve only the coated layer, but the underlying felt may also be involved in some circumstances.

Causes: Reasons for the formation of longitudinal fins on the internal surfaces of liners. The occurrence of longitudinal fins may be associated with the difficulties of measuring the perimeter of the host pipe resulting in an oversized liner.

This is most likely to occur in irregular shaped pipes, for example in egg-shapes, flat topped or flat bottomed conduits. Another reason may be the unintentional relative movement of coated and underlying layers which can occur at any stage of manufacture, impregnation or installation. Once a local excess of coated material has been induced it is unlikely that it can be pulled out and will remain as a fin. A common location for a longitudinal fin is along the edge of the layflat, often at 90 degrees from seam. (See Figures below).

Solutions: Longitudinal fins are difficult to avoid completely, but careful handling—avoiding the movement of layers relative to each other—would be one strategy. Closely observe the performance of the impregnation equipment, identifying locations where shear stresses might be occurring and plan to eliminate these locations by re-design or re-arrangement as required. During installation avoid situations where excessive longitudinal temporary tensile loads are applied to the lining which may cause relative movement of the layers causing longitudinal fins to arise.

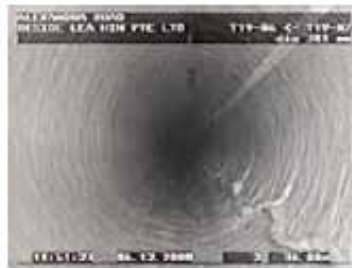
Figure 2 :: Large longitudinal fin.

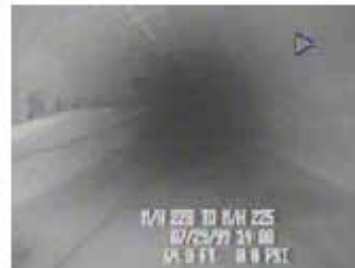
Figure 3 :: Another example of a large longitudinal fin.
