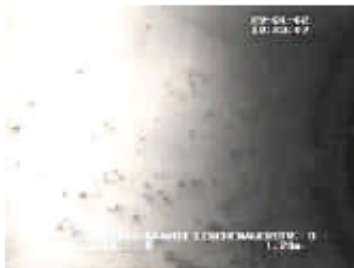
Spots have been observed on finished liners which may be associated with pin holes allowing water to pass through.

Causes: Spots on the surfaces of liners may be in some cases caused by a combination of the choice of resin and in particular, the choice of curing agent and the curing method (e.g., steam as compared with hot water and the choice of liner undersize).

Spots are formed by the filtering out of impurities in the water passing through tiny pinholes brought about under the conditions explained above.

Figure 1 :: Spots on liner.

Solutions: Spots on liners are uncommon and can be avoided by an informed choice regarding.

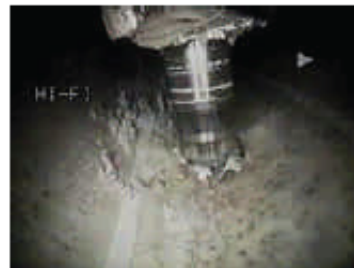
Figure 2 :: Spots associated with a change of section (e.g. manhole).
