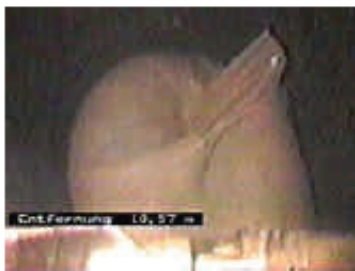
It has been known, especially in larger, longer liners, for the resin to gel prematurely which, when reporting to the inversion face, causes the inversion to stop. This is the cause of the issue in Figure 1 below.

The seam area in particular has prematurely gelled which explains the straight piece of liner which protrudes from the inversion face. The felt has become embrittled by the area of hardened resin and, unable to sustain the temporary loads, has torn.

**Figure 1 :: Example of stuck inversion with coated layer apparently trying to invert through split inner, note the cured section of seam.**

**Solutions:** Ensure strict adherence to quality control procedures.

The careful monitoring of resin handling and mixing, and testing for gel time may help to identify non-conformance likely to result in premature curing. Ensure that sufficient inversion pressure is available especially with smaller diameter liners.

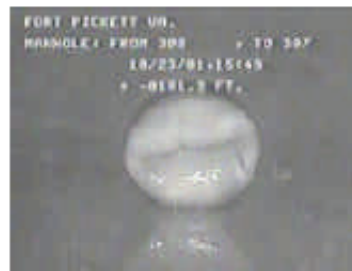
In Figure 2, the liquid resin is emerging from the inversion mouth. There appears to be a split in the inner layer on the lower right of the face.

**Figure 2 :: Example of stuck inversion with a split plain inner, or flame bonded across the inner layer.**
